THE DOME OF THE ROCK IN JERUSALEM

A Description of its Structure & Decoration

ERNEST TATHAM RICHMOND

FELLOW OF THE ROYAL INSTITUTE OF BRITISH ARCHITECTS
CONSULTING ARCHITECT TO THE NOBLE SANCTUARY IN JERUSALEM

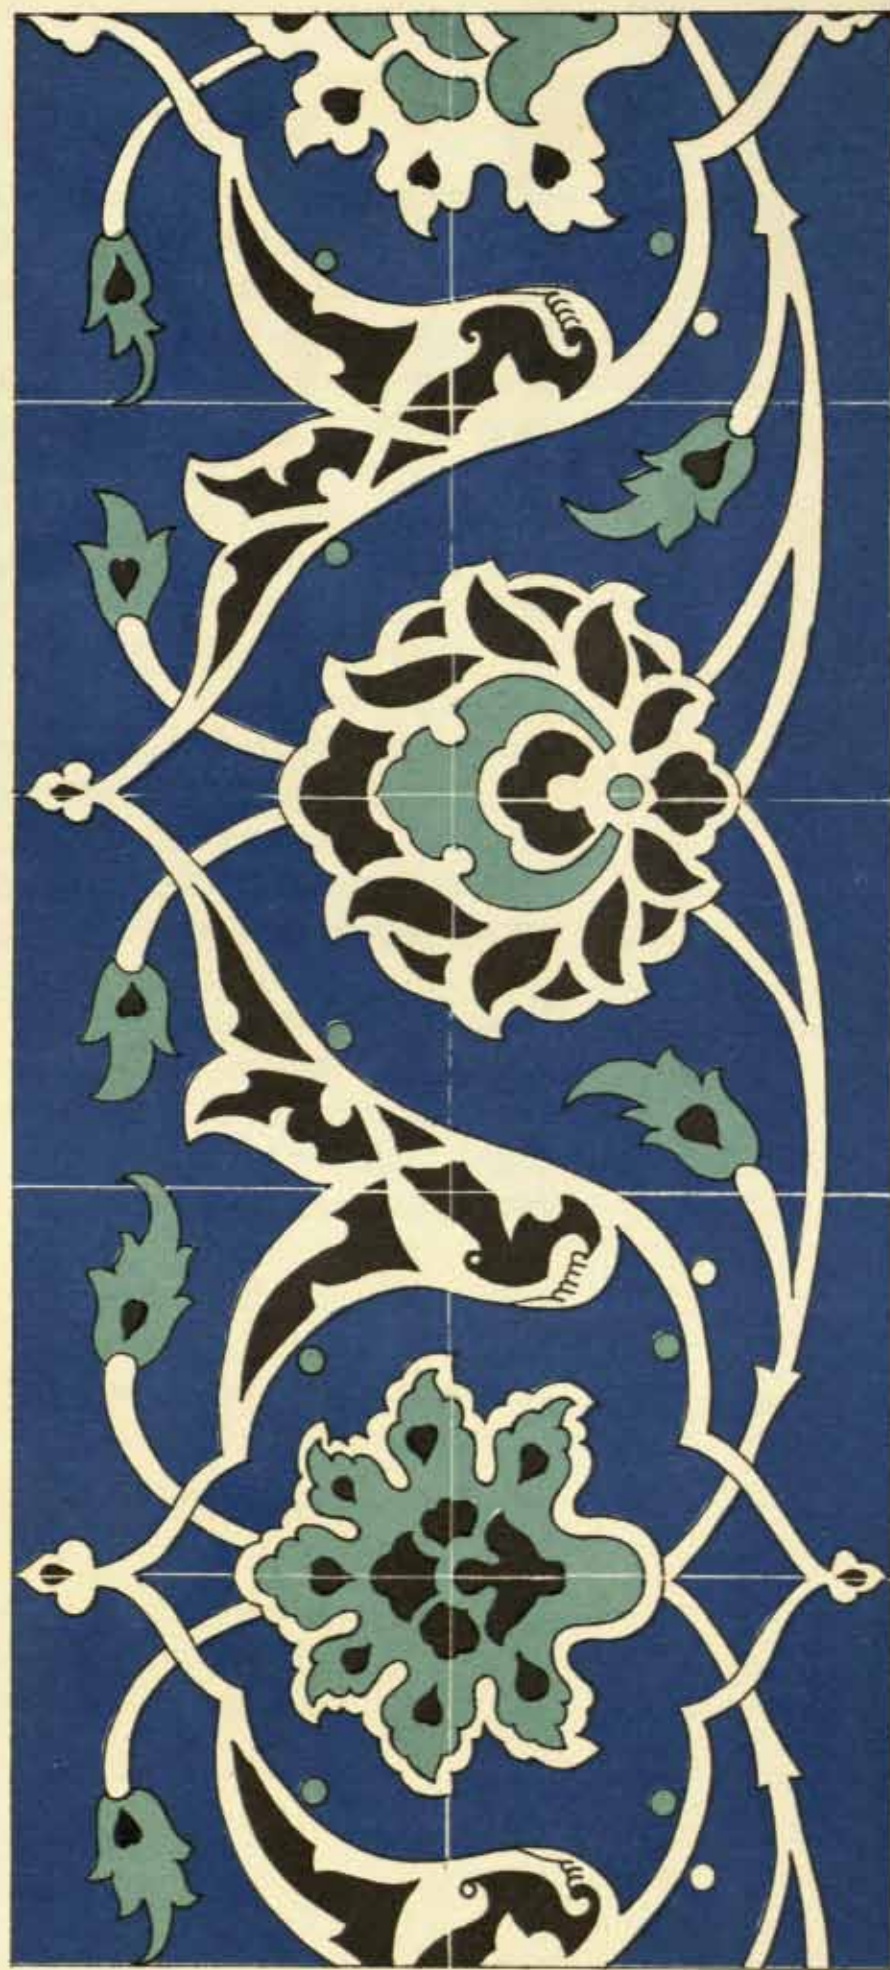
Fig. 40. Detail of border below great inscription on parapet wall. See also Fig. 41
Scale 1 : 4

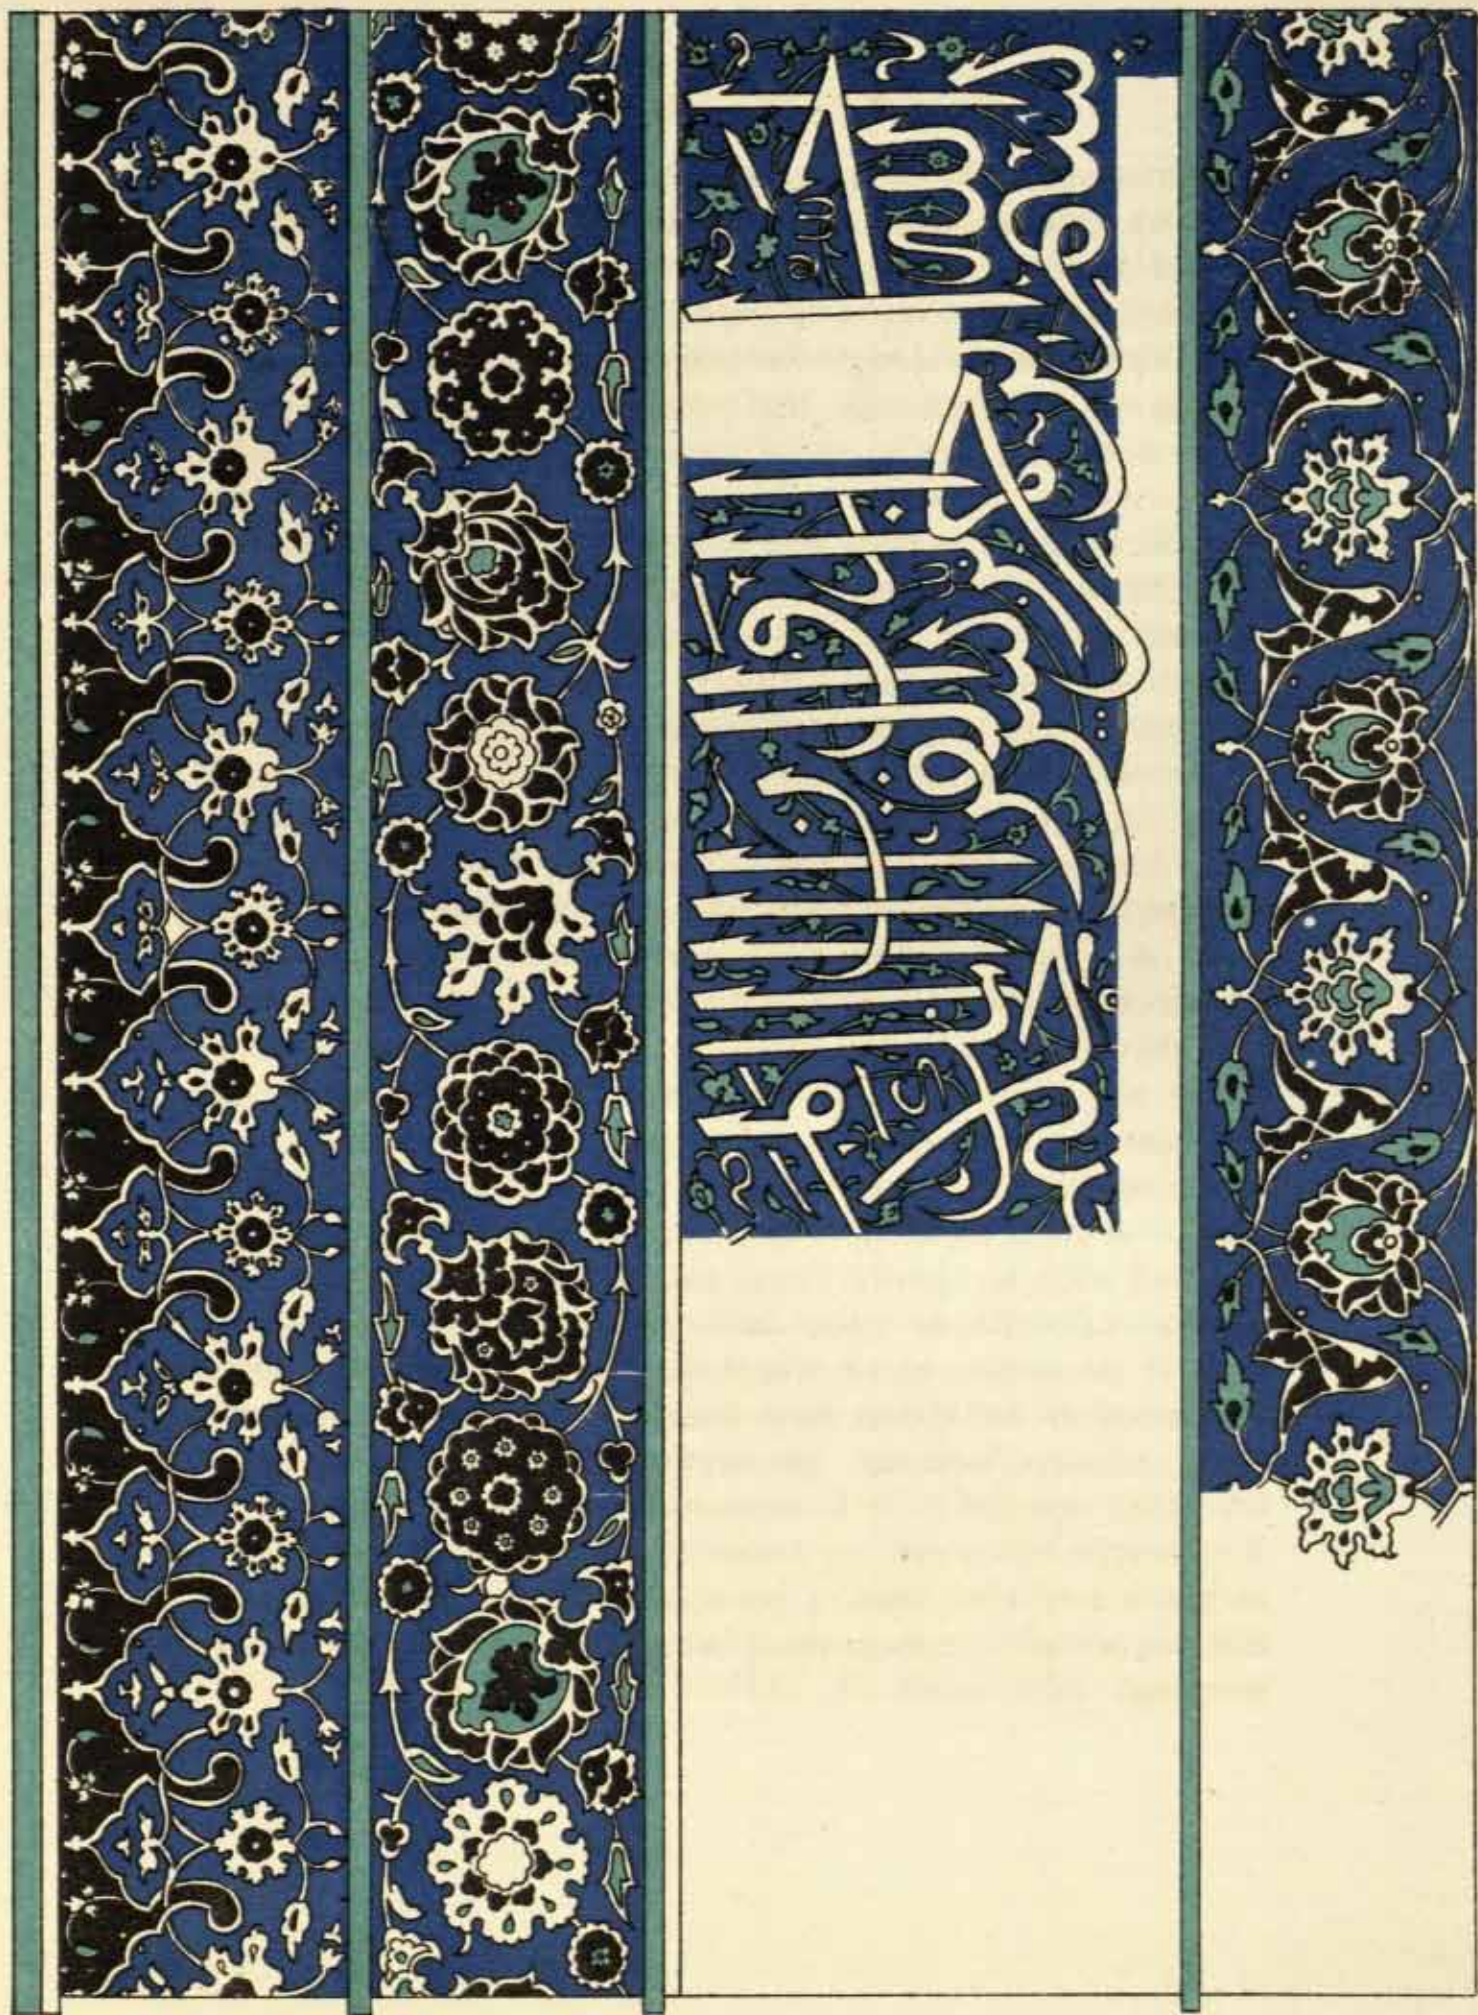
Fig. 41. Parapet wall: suggested arrangement of the tile decoration in the early 16th century

Scale 1:12.5

particular care the manner of its use. It is possible, then, that the panel treatment of the parapet wall was introduced sometime between 1842 and the early nineteenth century, say 1818, the date found on many tiles, and that at an earlier period there was a design for the parapet wall that included as one of its elements the pattern shown on Fig. 40 a pattern which, in view of its scale, is well adapted for a position so far from the eye. The tiles of this design are $20\frac{1}{2}$ centimetres wide and 23 centimetres high. A second element in the design was without doubt the battlemented pattern shown in Fig. 23 and already described in the second section of this chapter. The tiles forming this pattern are 25 centimetres square. A third element was the great sixteenth-century Koranic inscription already described and referred to as having been found in the store-houses of the Haram. This inscription, the remains of which are in the Haram Museum, is made up of three rows of tiles 25 centimetres square and one row $10\frac{1}{2}$ centimetres high and 25 centimetres long. A fourth element probably consisted in a row of glazed bricks set on edge above the cornice. A row of such bricks is found below the cornice, and, as is seen everywhere, they were used to mark structural lines. These bricks are 10 centimetres high. A fifth element was probably a band of tiles ornamented with the great floral pattern seen to a small scale in Fig. 41. These tiles have already been described in § 2. If these elements are superimposed and separated from one another by turquoise-coloured tiles of the thickness (3 centimetres) found in many parts of the building, the total height of the composition is $249\frac{1}{2}$ centimetres. The height of the parapet wall from the top of the cornice to the top of the highest blue band is 250 centimetres, a difference of $\frac{1}{2}$ centimetre, which is accounted for by jointing.

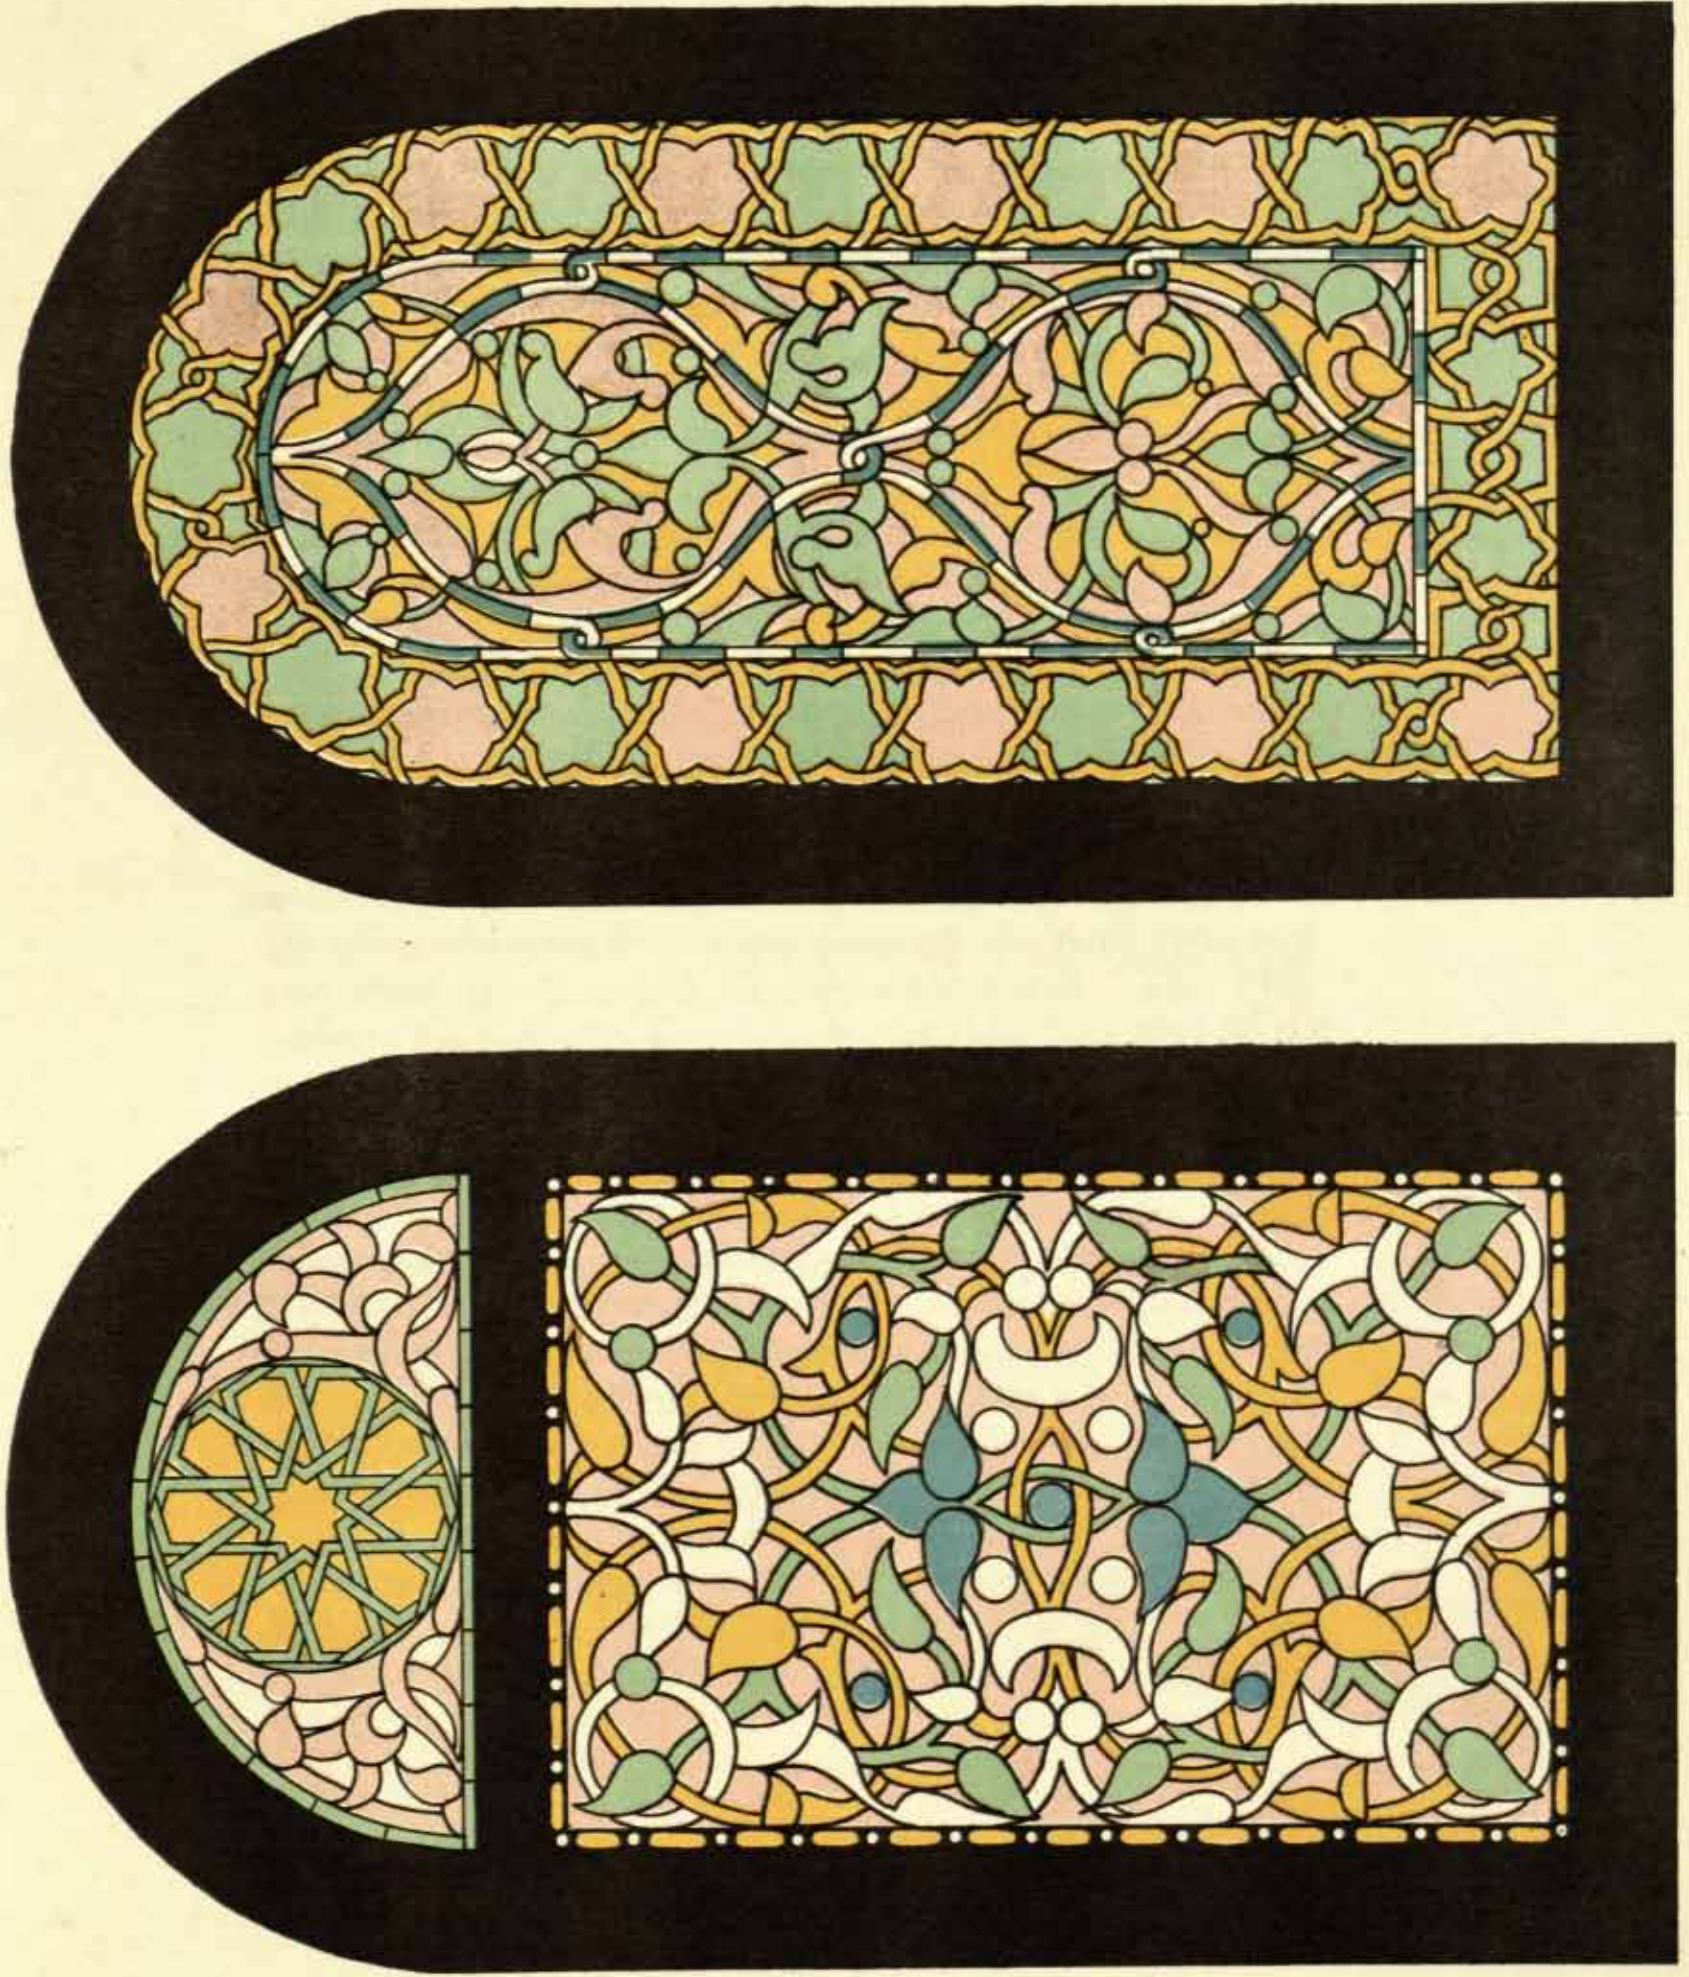
Figs. 67-8. Two of the windows in the drum
Scale 1:15.13

square in section. The designs of the oldest windows in the drum consist either of geometrical patterns or of interlacing floral scrolls of different colours. Figs. 67 and 68 illustrate two of these windows. The panes are large compared with those of the sixteenth-century windows, and the lines of plaster that take the place of the lead in our windows are narrow, barely more than one centimetre wide. The glass is set at a distance of from six to seven centimetres from the outer surface of the plaster. On the inside the glass is held in place by a fillet of plaster, bevelled on each edge, and about one centimetre wide and one centimetre thick, covering the joints between the panes. The sixteenth-century windows are made differently. The pattern is, as in the earlier windows, fretted in the plaster, but the glass is set on the outer surface. The panes are much smaller than in the earlier windows. The tunnels, through which the light trickles, are often wider on their inner than on the outer openings, and form cones sloped slightly downwards. The inner surface of the plaster is not flush over the whole area of the window, but is in two planes, one raised a little above the other; the main lines of the design fill the upper plane and the subsidiary lines the lower plane. The colours used are red, blue, green, yellow, and white. The older glass is streaked and filled with bubbles. The more modern windows are in a worse condition than the older windows, partly because they are in more exposed positions, but chiefly because they are not so well made. The older plaster is much harder and seems to have marble dust mixed with it; but analysis is needed to find out the exact composition.
